# Maryland Historical Trust State Historic Sites Inventory Form

historic Frame house

street & number north side of Sandy Hook Road, .15 mile west of Clark Road not for publicationcity, town Sandy Hook \_\_\_\_\_ vicinity of \_\_\_\_\_ congressional district sixthstate Maryland county Washington

Survey No. WA-III-103

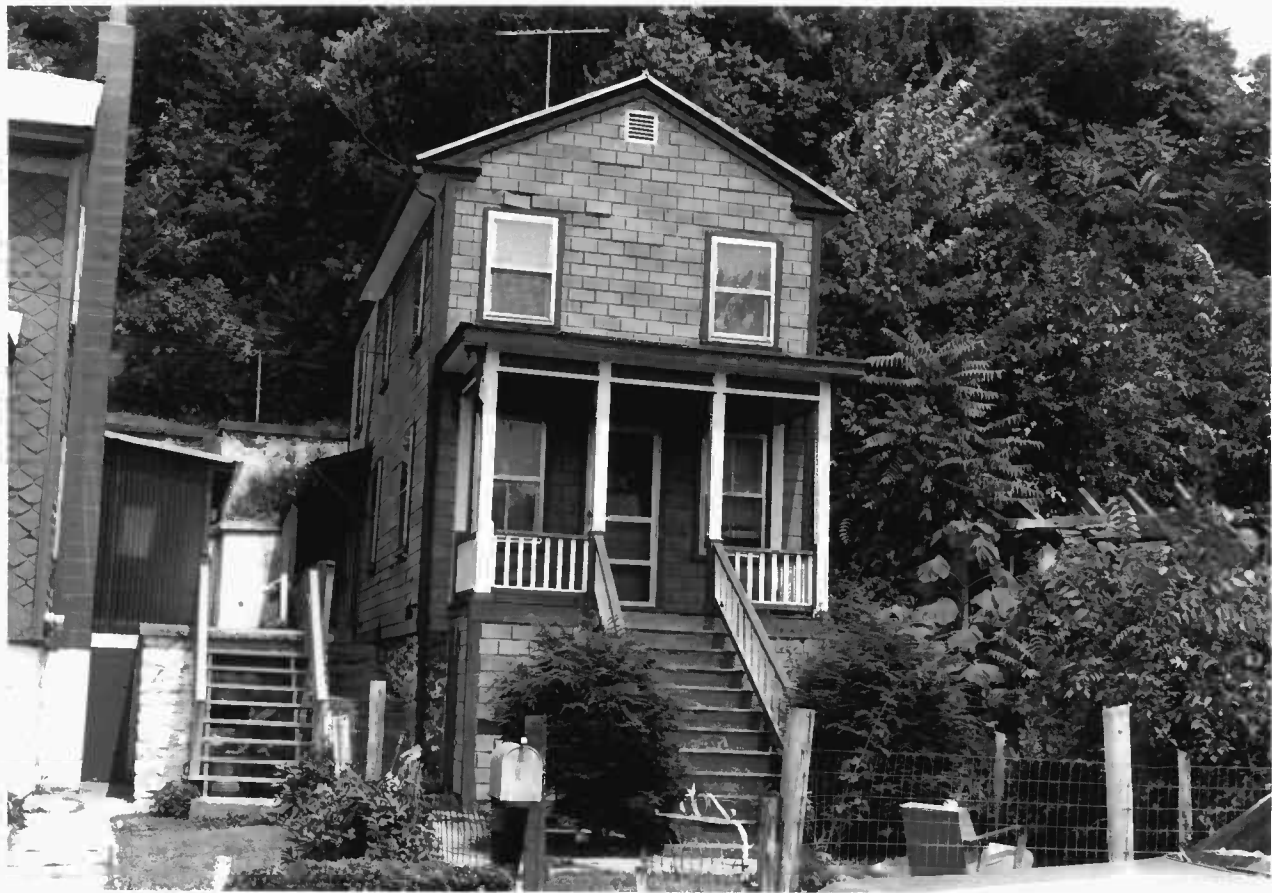
1. WA-III-103
2. Washington Co., Md.
3. Joe Getty
4. ~~April 1985~~ 7/82
5. Md. Hist. Trust, Annapolis, Md.
6. South elev. (camera facing north)
7. 1/1
